# **NAVAL STATION LONG BEACH FLEET MOORING INSPECTION REPORT**

**FP0-1-82 (24)**

**OCEAN ENGINEERING  
PROJECT OFFICE  
CHESAPEAKE DIVISION  
NAVAL FACILITIES ENGINEERING COMMAND  
WASHINGTON, D.C. 20374**

**20 DECEMBER 1982**

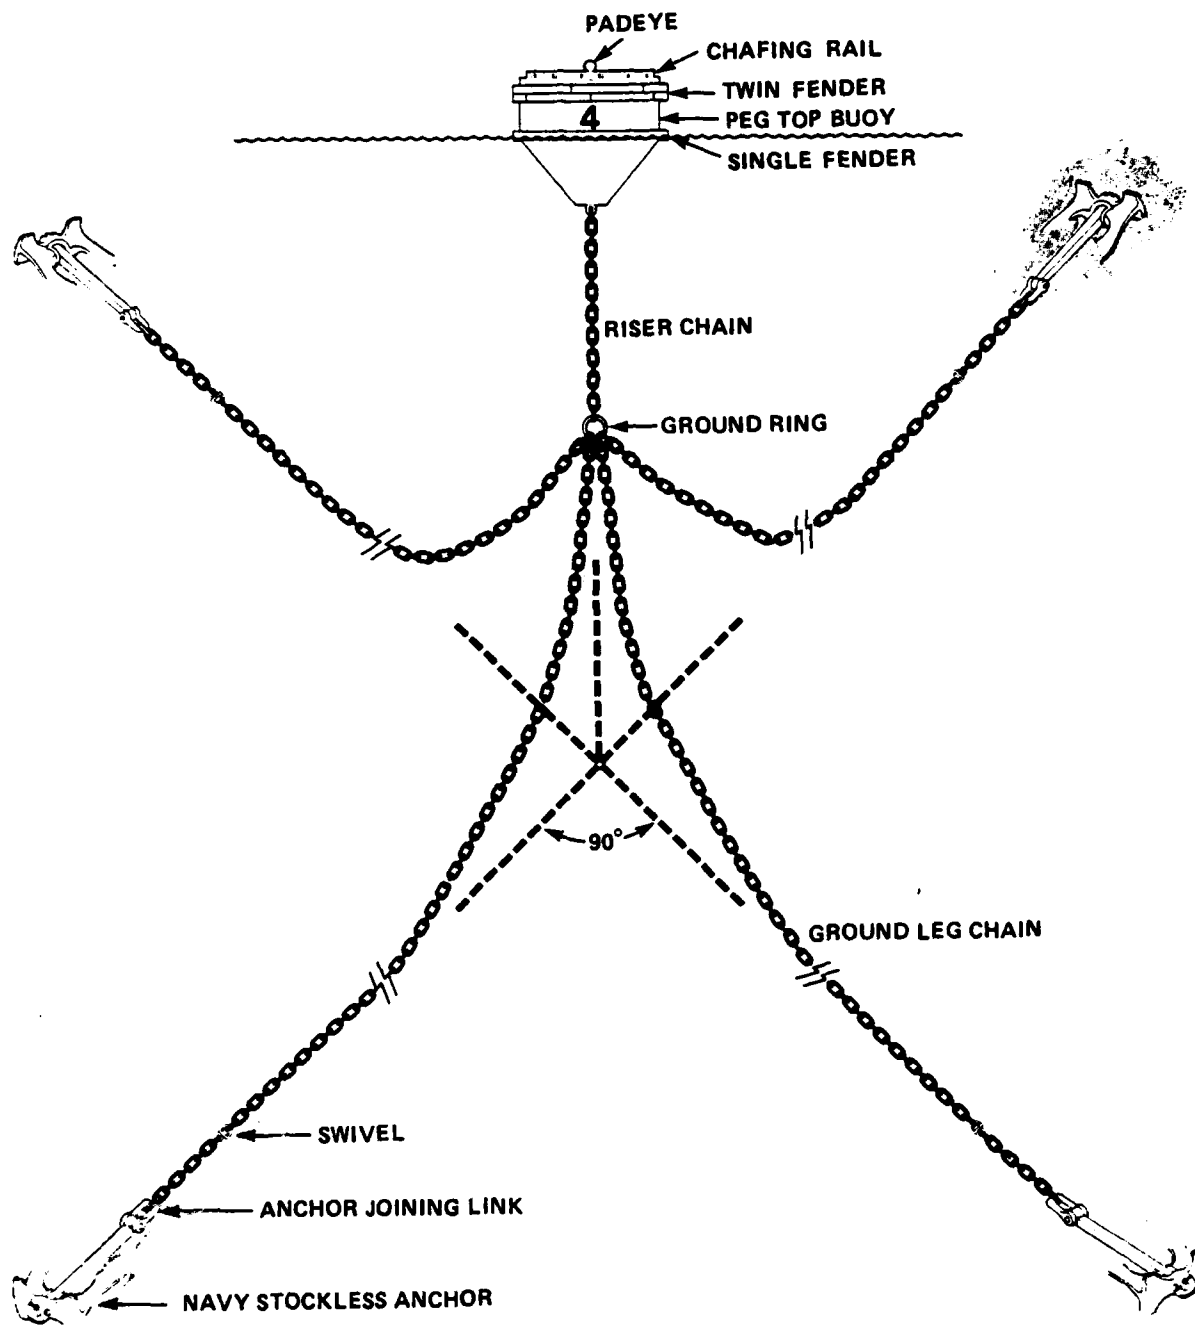
FIGURE A-1: SCHEMATIC DRAWING OF FM 4

This buoy is a painted Mark II 12'0" diameter Peg Top (S/N 181) with a 4'1" freeboard. The buoy has a wooden chafing rail and three wooden fenders, two parallel fenders near the top of the buoy and one at the waterline. Figure A-1 is an isometric view of the mooring. A five foot section of the lower fender is loose, and there are some light rust spots on the buoy's side. All top and bottom chain jewelry on the buoy are in satisfactory condition.

Although this mooring is reported to be a Class A mooring, it does not meet the DM-26 criteria for this class of mooring. A Class A mooring consists of 2-3/4 inch chain in both its riser and ground legs. According to diver measurements, this mooring has a 2-3/4 inch riser but only 2-1/2 inch ground legs which more appropriately meet the size requirements of a Class B mooring assembly. However, each leg of this FM-4 mooring contains only 2-1/2 shots of chain, and this does not meet the minimum requirement of 4 shots of chain per leg for a Class B mooring installed in 50-60 feet of water. In fact, 2-1/2 shots of chain per ground leg do not meet minimum requirements for any class of fleet mooring assembly installed in 50-60 feet of water.

NAVSTA Long Beach personnel should review their mooring requirements, based on the sizes of ships and environmental conditions expected to be encountered and determine the capacities or classes of moorings that are required. The existing mooring does not meet the design requirements for any class of mooring and should not be used by ships. However, it is satisfactory for the current use of securing camels and/or roller logs.

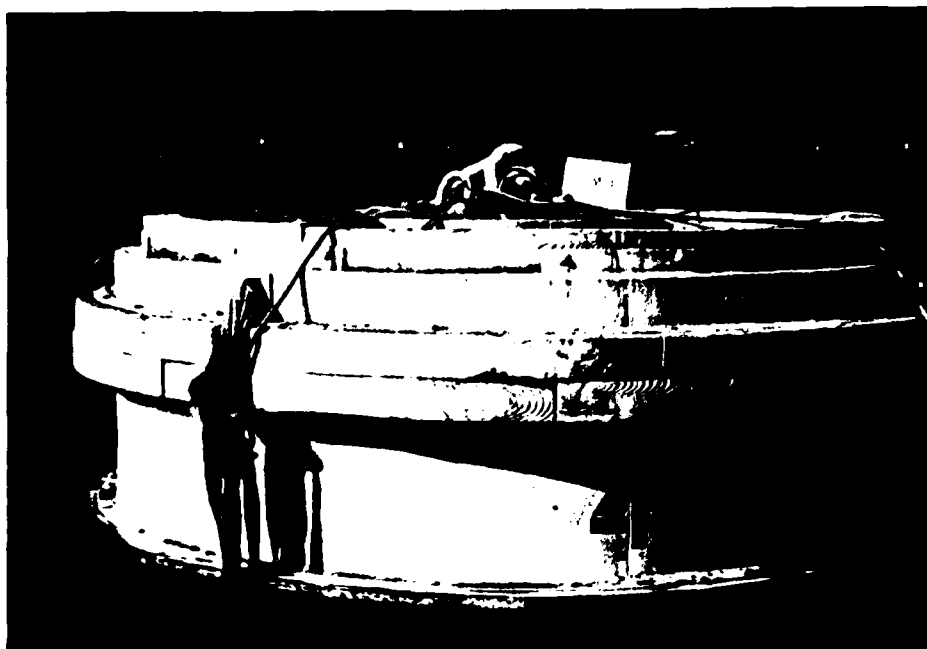
FM-4, Naval Station Long Beach

- Although reported as an "A" Class, this mooring only has 2 1/2" ground leg chain which more adequately meets the size requirements of a Class B mooring assembly.
- The material condition of this mooring, numbered FM-4, is good. However, due to its relatively short ground legs, this mooring does not meet the established criteria for inclusion into any class of fleet mooring as specified in DM-26.
- The buoy, a 12-foot diameter Mark II Peg-Top, has some light rust spots on its sides. Otherwise, the buoy and its top and bottom jewelry are in satisfactory condition.
- A five foot section of the lower buoy fender system (at the waterline) is loose.

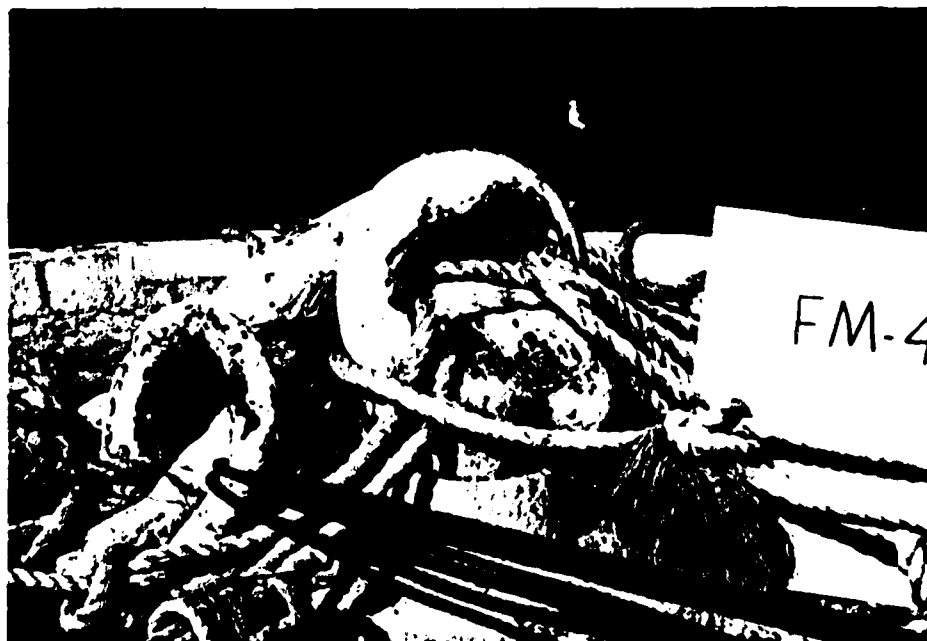
FM-4 top jewelry

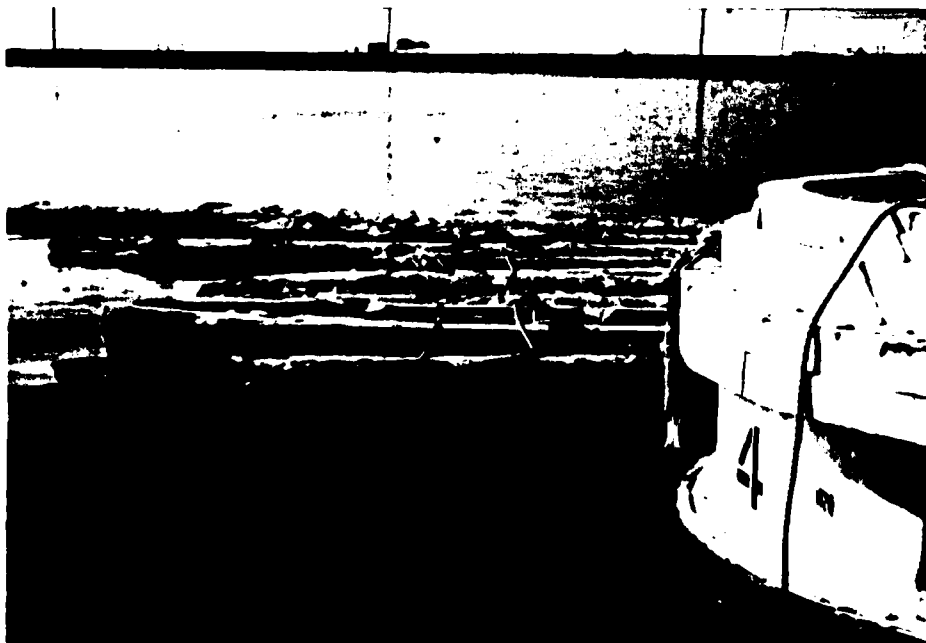
- Measurements taken of chain links and fittings were all greater than ninety percent of the original wire diameters.
- The Harbor Operations Officer advised that, due to more than adequate pier space, this mooring is never used by ships. Instead, it is primarily used for securing spare camels and/or roller logs.

Roller logs lashed together and tied to the mooring
